TRICKS of the TRADE

Volume: 03182007 • March 2007 • PMA 0010-19 TB

Eliminate Grout Leakage on the TB 110

A Fit and Trim TB 110

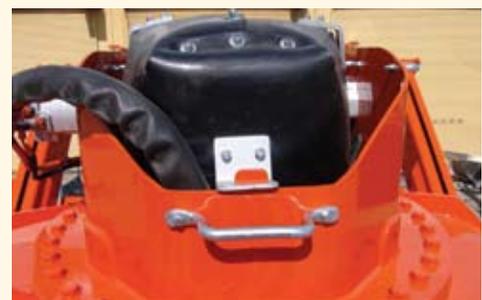
When properly installed, the bracket on the feeder boot should look like this.

A properly installed bracket on the feeder boot of your TB 110 will keep your jobs running smoothly. If the bracket is mounted upside-down, the front of the boot will drop down, restricting flow through the transfer. The bracket should be mounted with the bolts up and the slotted flange down. Simply check the bracket and flip it, if necessary, to enhance efficiency.

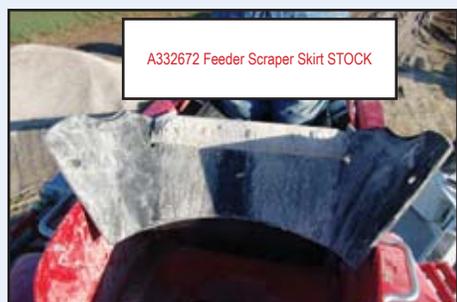
Standard TB 110 feeder scraper skirt.

Leaking grout around the ends of the feeder head scraper is messy and means additional clean up time. While all active-feeder units – TB 80, TB 110, TB 130 – use the same feeder scraper skirt (part number A332672), the feeder drive pulley on the TB 110 is pulled toward the edge of the transfer farther than the other two models. This results in short scraper arms that allow the skirt to rotate away from the arms when the scraper is pulled into position. Two problems ensue:

- The “wings” on the top edge of the skirt rotate back and block access to the side of the blade. This makes it very hard to clean the blade through the oval access holes on the feeder head. These “wings” may even fold under the pulley if the operator installs the discharge boot incorrectly. This creates a big mess.
- The sides of the skirt rotate up and contact the drive pulley or the bearing boxes. When the scraper springs are tensioned, the skirt contact minimizes proper blade contact.

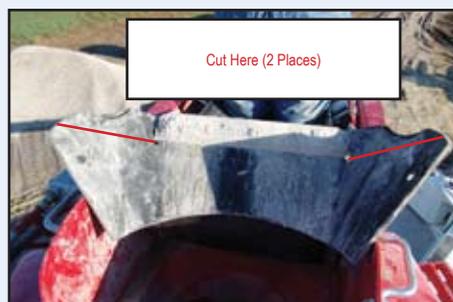
Cuts in the feeder scraper skirt should start at the skirt notch at the ends of the skirt clamp.

While this issue is now being corrected on new models in production, owners of TB 110s currently in the field can alleviate leakage and restore access to the sides of the blade by simply cutting the skirt as shown below. When the scraper assembly is reinstalled, the skirt should not touch the pulley or bearing boxes. As the discharge boot seals the gaps, operators should not experience any problem with splatter getting over the cut.

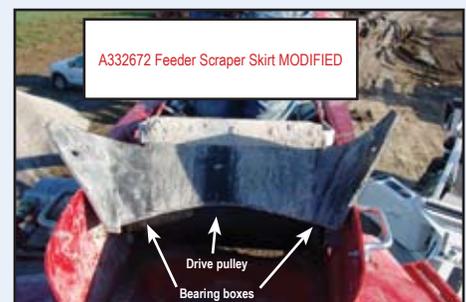
Dimensions are not critical; just ensure the cuts simulate those pictured.

A good starting point for feeder scraper tension, with a sharp blade and springs that have not been stretched, is with the hairpins in the fourth chain link. Simply ensure that the sides of the discharge boot are INSIDE the ends of the scraper skirt.

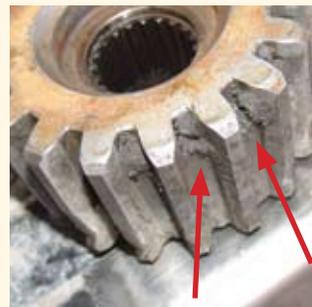
Arrows indicate fines packed into teeth. Allowing this to persist will result in performance issues.

As noted in every issue of the Tricks, owners should be diligent in keeping all areas of their Telebelt free of debris. This is especially important at the feeder slewing drive on all machines. Material buildup under the feeder slewing gear cover can result in increased wear and costly maintenance.

By removing the chain or gear cover (depending on model) and cleaning the area, owners will protect their investment and ensure their Telebelt continues to perform reliably.

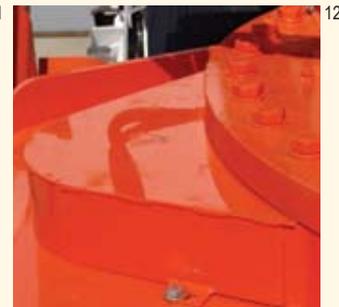
Putzmeister is constantly working on ways to ease maintenance and enhance performance of its Telebelt models. This includes a new three-piece cover for the slewing gear on the TB 110.
